Gazetteer of Historic Buildings in New Buckenham

by Sue Brown, Michael Brown and Paul Rutledge

**Journal of the Norfolk Historic Buildings Group
Volume 2
(2005)**

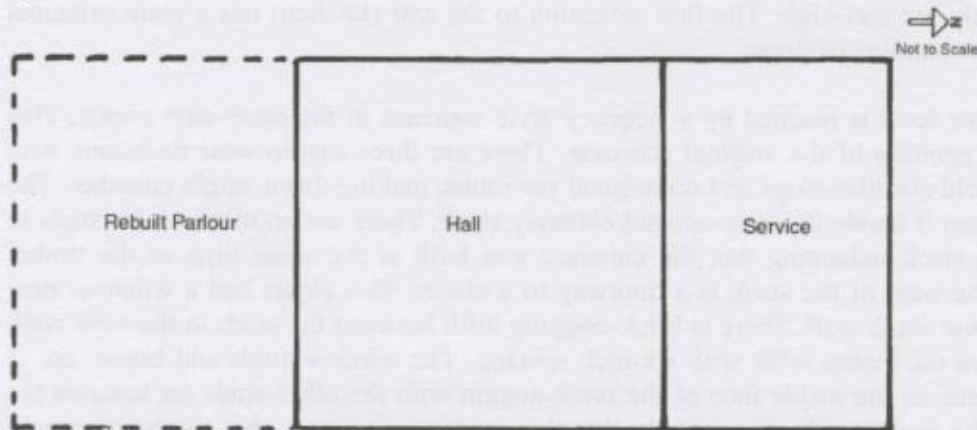
The Rookery, Boosey's Walk, New Buckenham (R.4-5)

The house is faced in brick and presents differing forms of fenestration and roof line as alterations have been made. The north of the building is a timber-framed room, now used as a sitting room but probably the original kitchen. The principal joist has no stops but only a simple chamfer and this joist shows signs of erosion by moisture. The west wall was originally the outside as it is very weathered. There is a scarf joint (edge-halved with under-squinted bridled abutments and two edge pegs, early fifteenth century) in a timber reused (perhaps from the original house) for the head of the window in the north wall. The extension to the west is said to have been the dairy. This is a later addition either in solid brick or possibly brick and clay lump. The stairs rise in the chimney bay to the east. The present kitchen (original hall) has a massive principal joist with a lamb's tongue stop and notch. The common joists are tenoned into the principal with diminished haunch soffitenons. There is an ovolo moulding in plaster used as a cornice. The original parlour wing has been rebuilt in brick, evidently in the late eighteenth or early nineteenth century, with subsequent Victorian additions. The kitchen and hall are approximately thirty-two feet in length and the original length of the parlour wing is probably sixteen feet six inches (one rod), as this is the measurement to the wall of the staircase hall. At a later stage the staircase hall was remodelled (blocking a ground-floor eighteenth/early-nineteenth-century window) and the bays were added to the sitting room and dining room. These two rooms each have a moulded cornice (not matching) and this moulding is extended to take the later addition of the two bay windows. The sash windows in these rooms have 'horns' whereas the sash windows in the bedrooms above the present kitchen have no horns. The sash windows in the bays are flanked by brick pillars and then single French doors, suggesting a mid-nineteenth-century date.

The dairy wing has English bond brickwork on the ground floor and Flemish bond at first floor level rising to a parapet, showing the latter to be a Georgian addition. The north window above the dairy shows evidence of once being a doorway, probably to give access to the attic floor. The roof above the dairy and former kitchen and hall has been replaced with a substantial king-post roof that is probably eighteenth century or early nineteenth

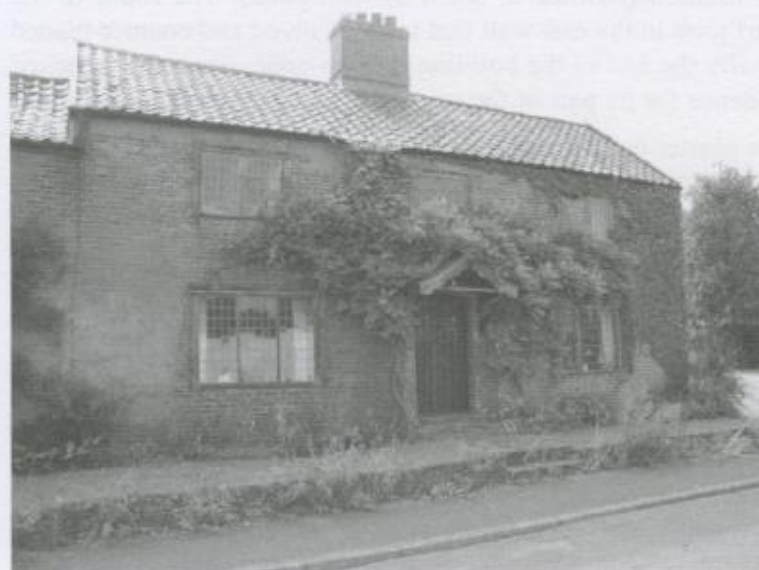
Pinchpot appears to be a twentieth-century 'Arts & Crafts' style house from the exterior. It is clad in brick with lead-light windows in modern frames (1980s) made from moulded sixteenth-century timbers.

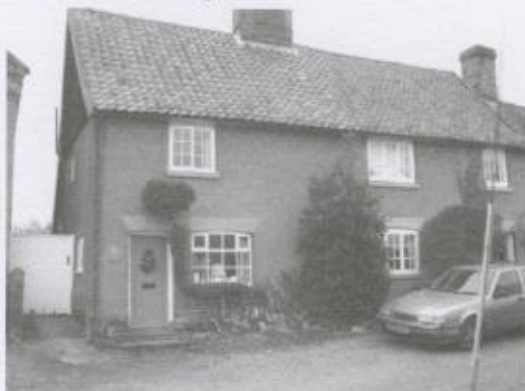
Nos. 1 & 2 Chapel Hill are now the two halves of a house fronted with brick under a pantiled roof, giving no external indication of the historic structure within.

In No. 1 the single room at ground-floor level is completely timber-framed with a brick fireplace taking most of the north wall with a small recess either side. There is a recent extension to the rear for the kitchen. The principal axial floor joist has a shield stop with a large notch to the chamfer, as found next door in No. 2. This joist is tenoned into the girt and into the transverse joist above the mantle beam. Opposed shield stops and notches are used decoratively in the centre of the transverse joist where the axial joist joins. The common joists are laid flat and may be housed but the jointing is still very tight. On the mantle beam are several taper burns. The front east wall may have had a large window or a window and doorway. There may have been a window in the south wall near the corner to give a view down the street. The west wall has the sill set at a higher level than the front east wall, as seen elsewhere in New Buckenham. There was a window three feet wide in this wall, evidenced by the surviving pegged tenon of the window sill and the empty mortice for the other framing stud.

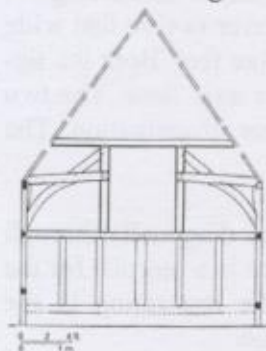
Figure A 2 Chapel Hill

There is evidence of a three-diamond mullion window above the hall in the soffit of the west wall-plate (with its sill) and a corresponding window in the east wall (sill only). The front wall-plate has been replaced twice (both in situ) and there is a cut-out for a dormer window. In the east chimney bay there is an elbow piece for the roof raise secured by a forelock bolt. The chamfer-stop on the mantle beam is a shield with a large notch. The north-east corner post has a sharply-cut jowl with a scribed carpenter's assembly mark of II. There is another diamond mullion window in the north-east wall-plate. This wall-plate has a later addition bolted on. The collar in the north-east chamber is a re-used timber. The north wall, above the tie-beam, has primary bracing, suggesting a late-seventeenth or early-eighteenth-century date for the roof-raise.

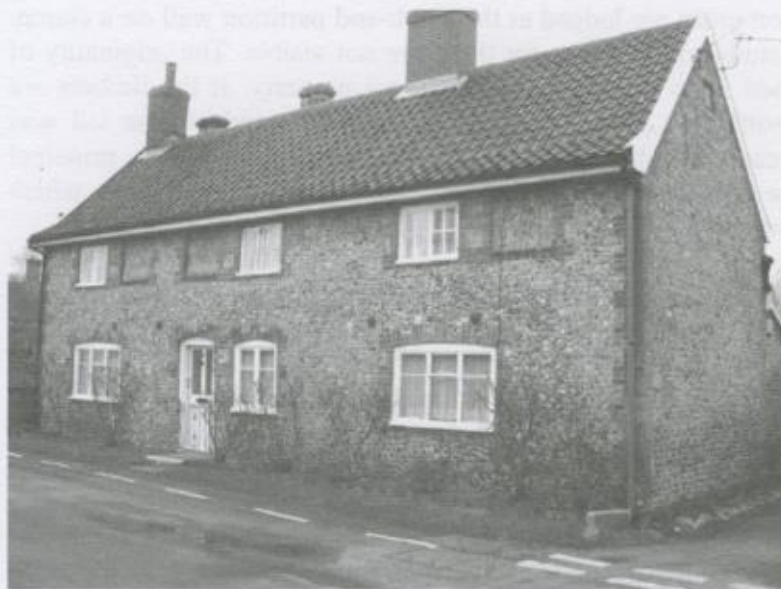
Rose Cottage, Chapel Street, New Buckenham (R.31a)

A brick-and-flint cottage with a pantiled roof, aligned east to west on the north side of the street. The brick-and-flint front is typical of an early-nineteenth-century date when it appears to have been three cottages.

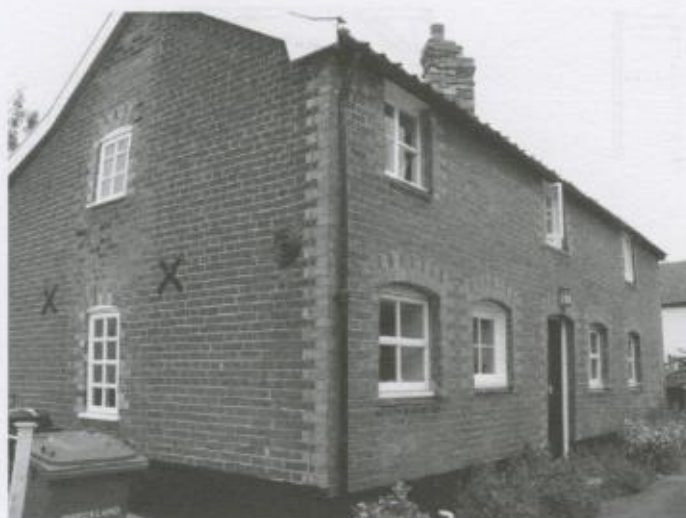
The present building of one-and-a-half storeys appears to be a former open hall into which a floor and chimney were inserted at some later date, probably in the early seventeenth century.

A window rebate was found in the north end of the western wall-plate (Fig.A). There is a mortice in the soffit of the wall-plate for a window mullion. The stud to the north of the rebate is not pegged but applied to the wall-plate. This stud has a peg hole, possibly for a door lintel and a rebated edge for the door.

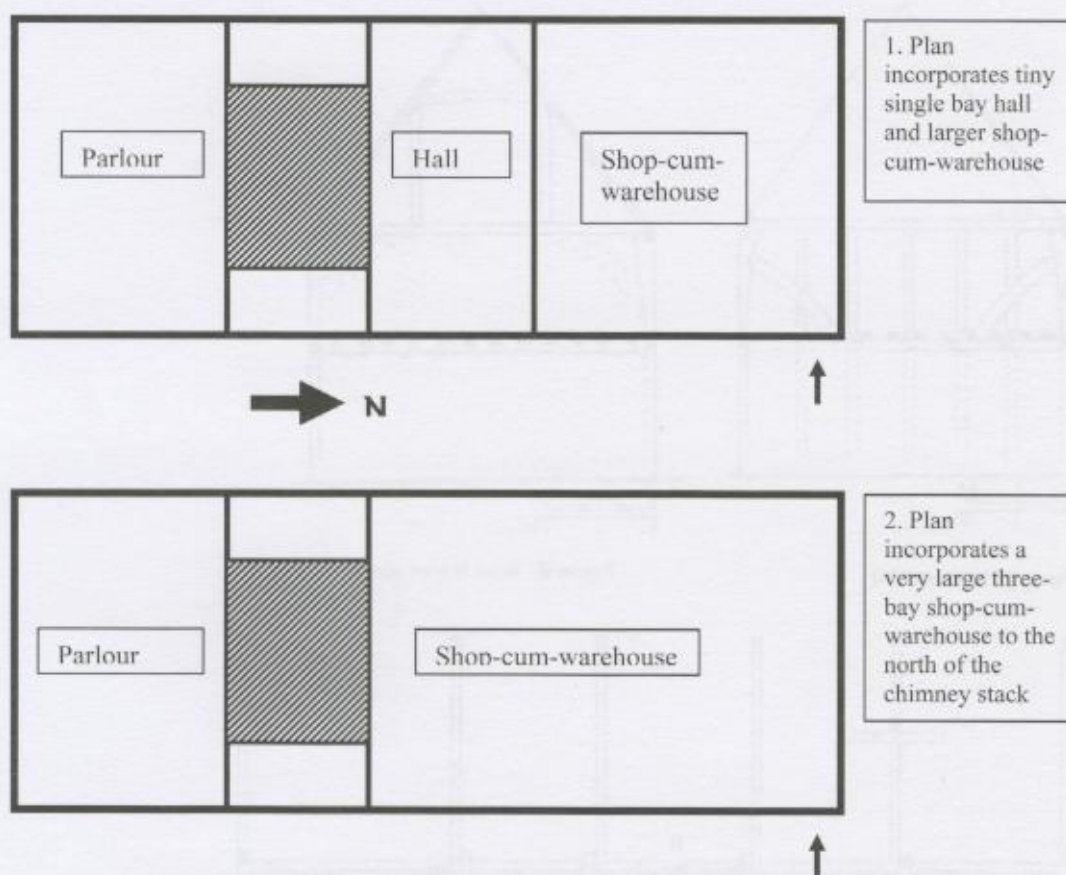
Fig.F: Two interpretations of the sixteenth-century ground-floor plan arrangement, The Pleasance

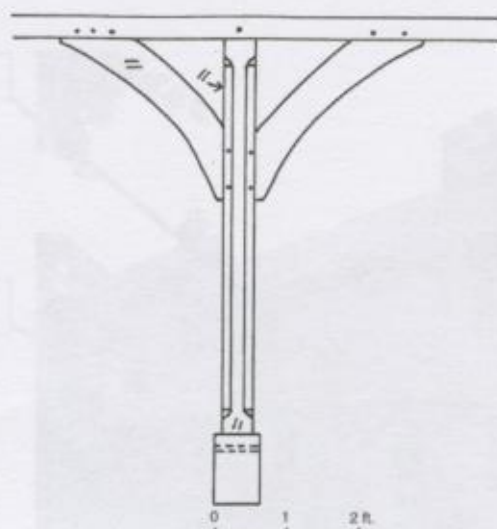
Figure A Crown Post (Truss C)

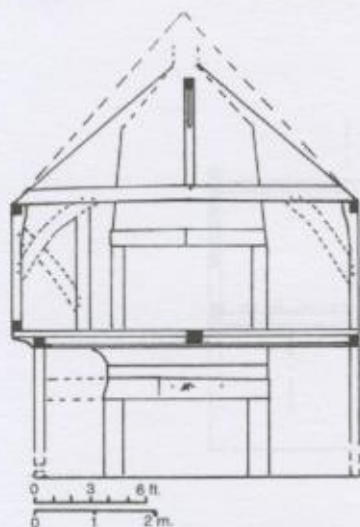
Figure B Truss B (from the West)

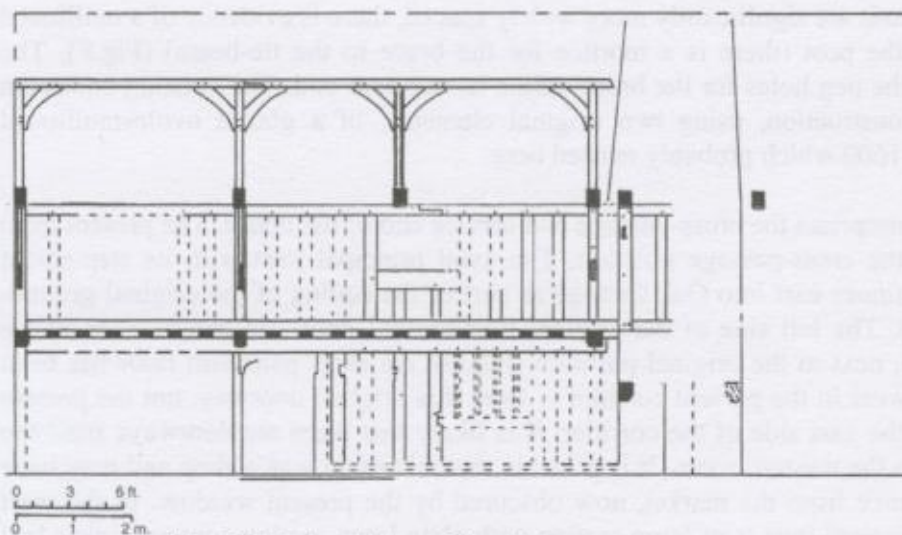
Figure D North wall (showing Crown Posts)

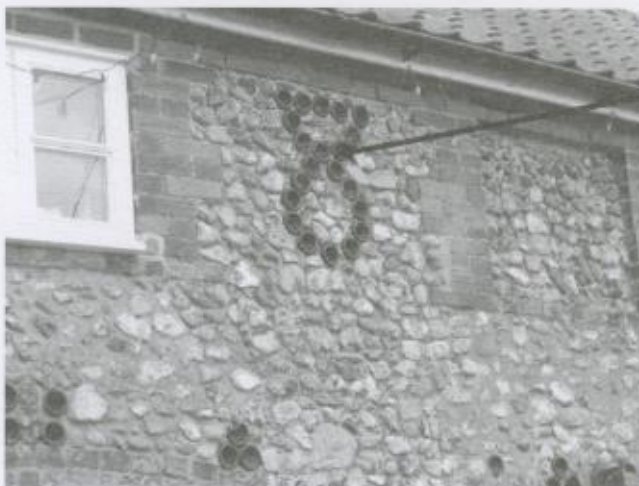
Date inscription of 1820
contrived by putting empty
wine bottles to good use

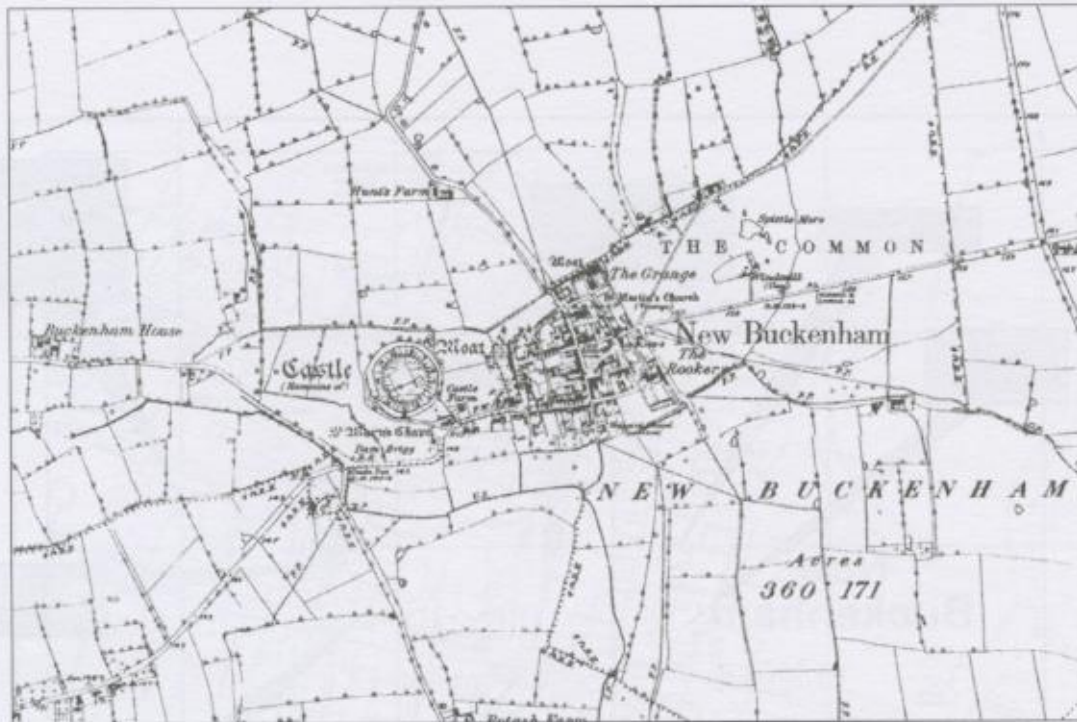
Figure 49

Map showing the location of the properties sampled during this project. Reproduced from the Ordnance Survey's Superplan data, with the permission of the Controller of Her Majesty's Stationery Office © Crown Copyright 2004 Licence No AL 50228A. Scale as printed c. 1:3300.

Timbers within 10 buildings, comprising eight structures, were selected for sampling (see **Figure 49**): Old Vicarage and Pinchpot in Chapel Street; Burrage House and The Old Post Office (these contain parts of the same original structure), The Old Swan (Diken Cottage contains part of the same structure), and The White Horse all in King Street; Oak Cottage

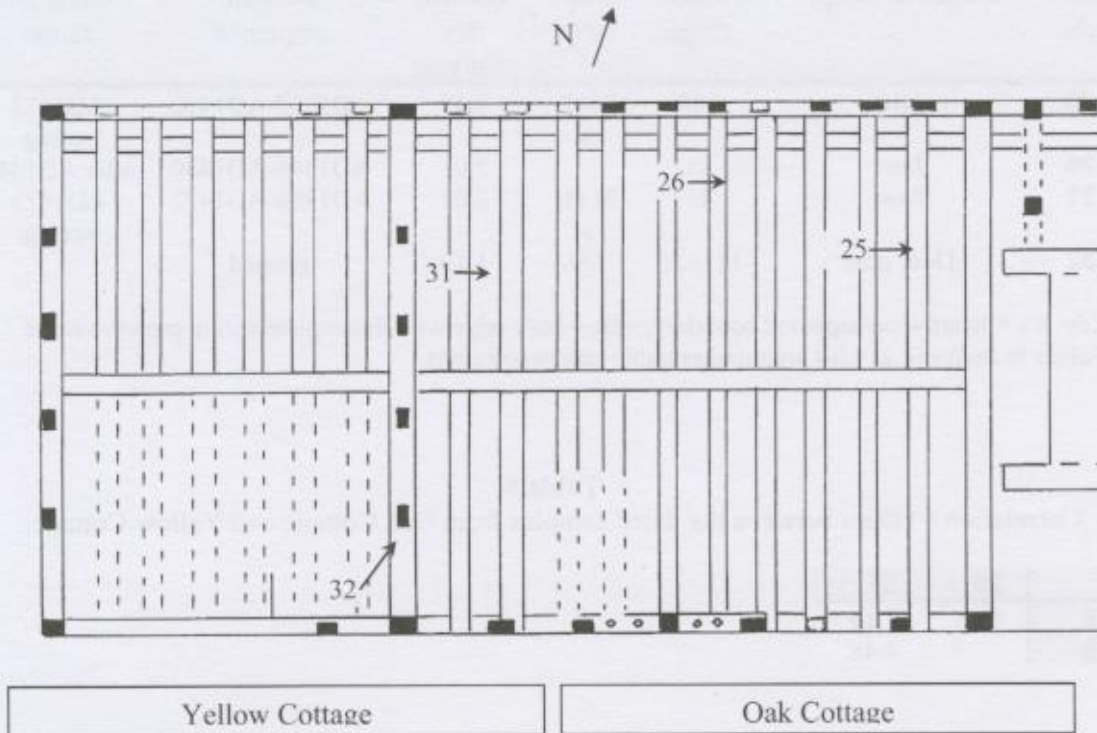
A plan of Oak Cottage and Yellow Cottage. The smaller numbers with arrows show the approximate location of each sample (figure supplied by NHBG).

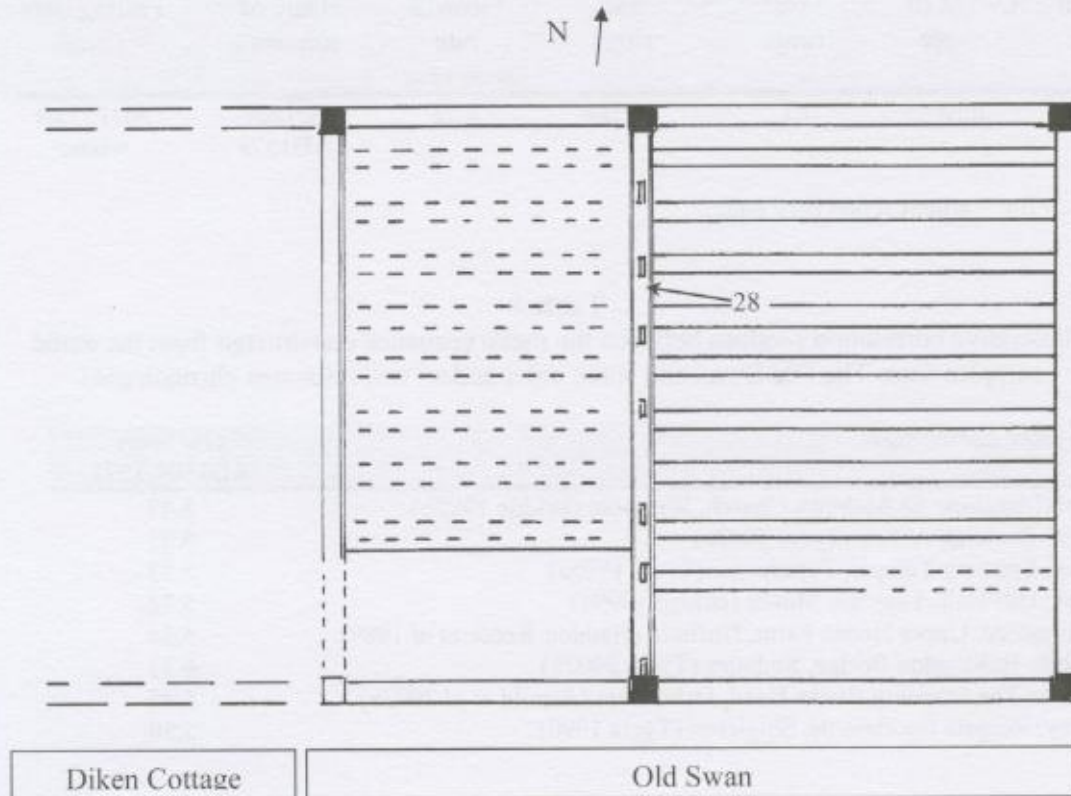
A plan of The Old Swan. The small number with arrow shows the approximate location of the sample (figure supplied by NHBG).

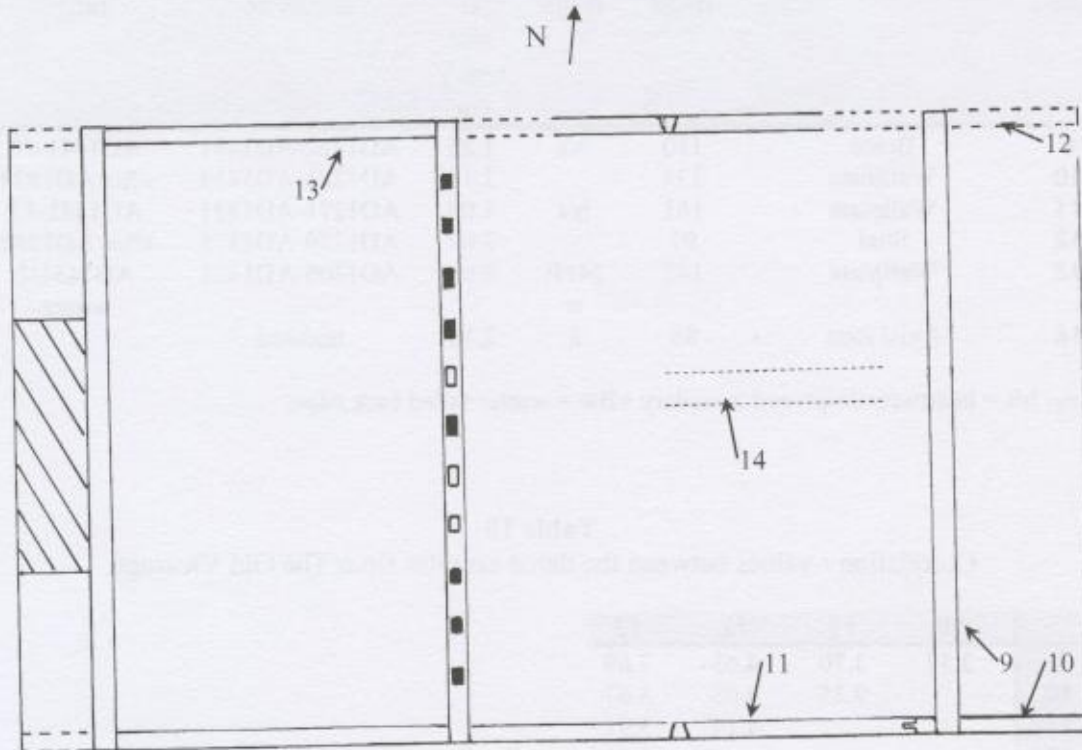
A first-floor plan of The Old Vicarage. The smaller numbers with arrows show the approximate location of each sample (figure supplied by NHBG). Sample 14 is from the ground floor ceiling.

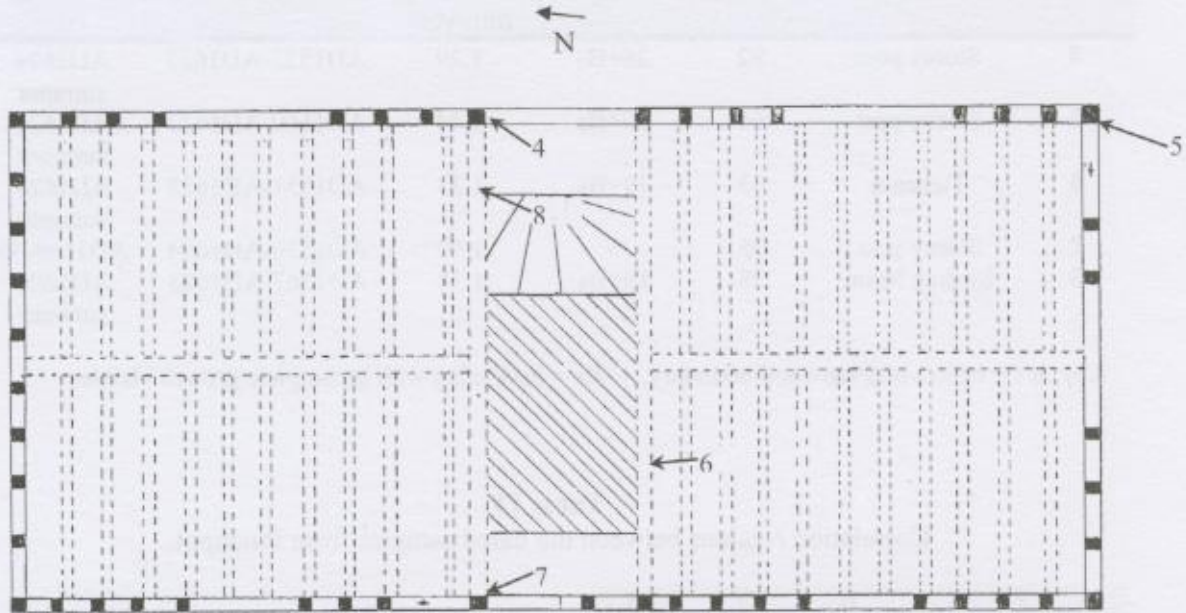
A first-floor plan of Pinchpot. The smaller numbers with arrows show the approximate location of each sample (figure supplied by NHBG). Sample 8 is from the ground floor ceiling.

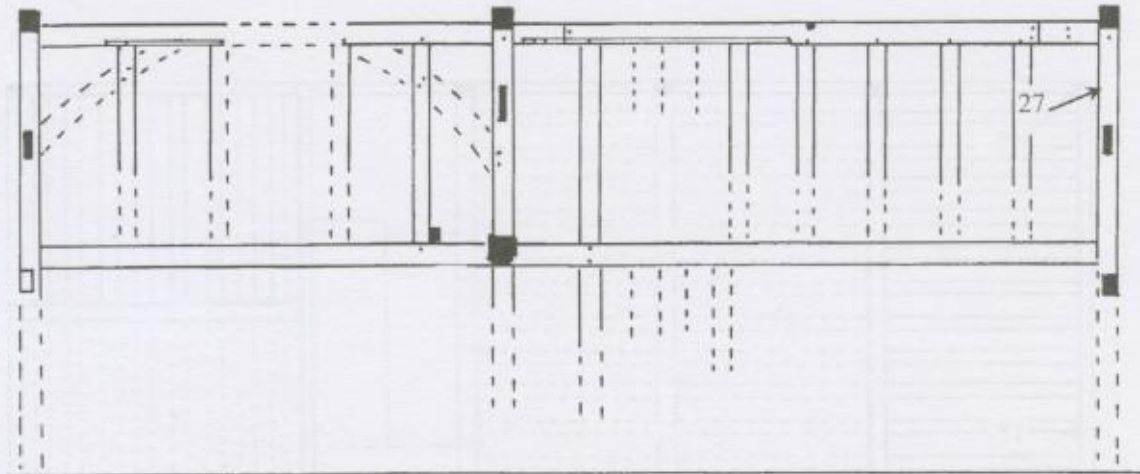
The east wall of Tanyard Cottage viewed from the west. The small number with arrow shows the approximate location of the sample (figure supplied by NHBG).

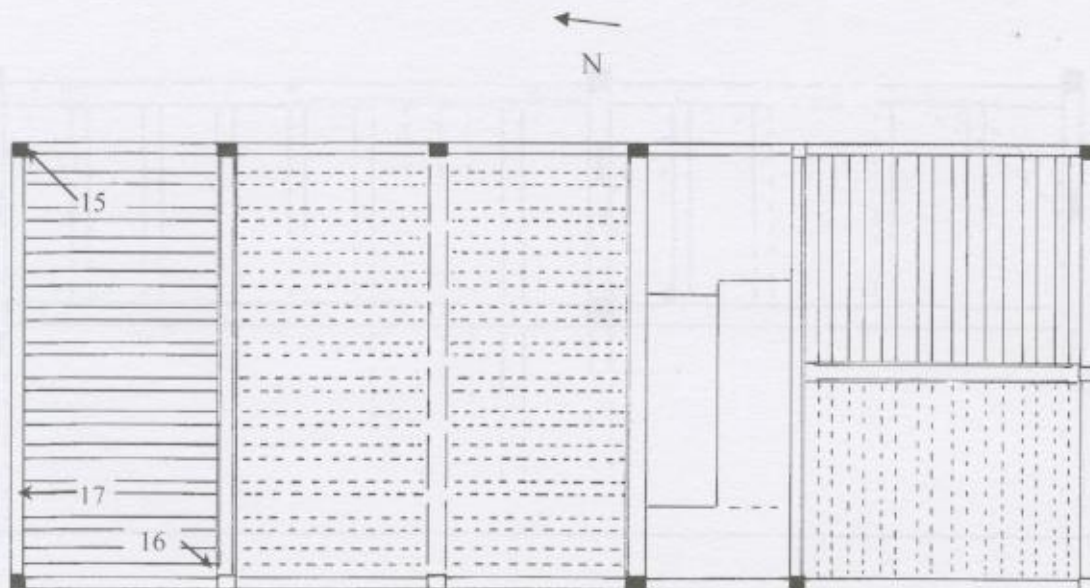
A plan of The Pleasance. The smaller numbers with arrows show the approximate location of each sample (figure supplied by NHBG).
