JOURNAL OF THE NORFOLK HISTORIC BUILDINGS GROUP

THE HISTORIC BUILDINGS OF NEW BUCKENHAM

EDITED BY ADAM LONGCROFT

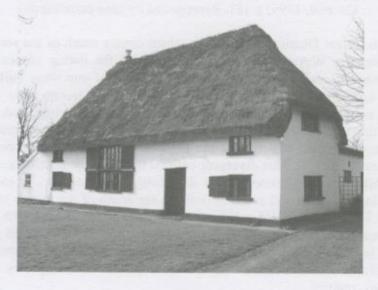
Figure 6
White Cottage, High Common, Wacton.
(Photograph by Adam Longcroft)

the county. New Buckenham lies on the boundary between two rural districts: Wayland to the west and Depwade to the east. Both possess a large number of listed buildings, though Depwade has 12.3% of the total number for the entire county – a figure which is twice as high as the next highest district. The density of surviving timber-framed buildings is quite remarkable in this part of the county and, once again, is mirrored across the Waveney in the claylands of central and northern Suffolk. By the end of the sixteenth century a number of features had begun to emerge which, taken together, illustrate the basic character of the 'post-medieval' stock in south Norfolk. Firstly surviving medieval buildings tend to conform to a tripartite plan incorporating parlour, hall and service. Normally the hall comprises two bays. Houses tended to be tall and relatively well-built and the constituent ground floor rooms were normally arranged in-line. White Cottage, Wacton, could be said with some justification to be a 'typical' late medieval hall-house of south Norfolk type. Erroneously described by Pevsner as a Wealden, it is, in fact, nothing of the sort (see Figure 6).

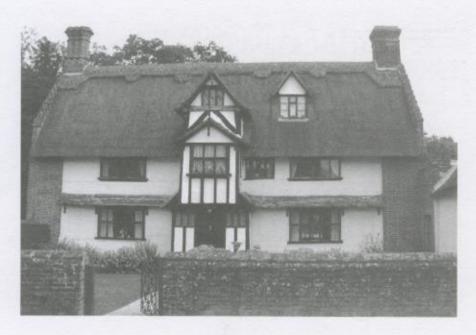
Figure 16
Dairy Farm, Tacolneston, Norfolk.
(Photograph by Adam Longcroft)

High levels of wealth are reflected in significant concentrations of houses with brick-built crow-stepped gables, most of which were erected before 1650.59 Crucially, brick was also used to construct substantial axial brick chimney stacks, many of which were endowed with multiple flues. This resulted in a proliferation of multiple-hearth houses from the latesixteenth century most of which, as we have seen, possessed either a cross-passage plan or a lobby-entry plan. It is apparent, therefore, that small cottages appear to have proliferated in the arable area of north Norfolk, whilst larger farmhouses with multiple hearths seem to have been thicker on the ground in the claylands of south Norfolk. As has been suggested, this was almost certainly the product of a more egalitarian social structure and a more even distribution of wealth. But it may also reflect the emergence of divergent vernacular building traditions within the county. Across the north of the county a flint building tradition had emerged by the sixteenth century. This favoured, for reasons of economy, the use of gableend chimney stacks. In communities where most people could only afford houses with one or two rooms on the ground floor, a single gable stack incorporating one or maybe two hearths at the most usually sufficed. In south Norfolk, by contrast, the large number of sophisticated multi-hearth houses may reflect not just a concentration of wealth within a dominant and very large class of moderately prosperous yeoman farmers, but also a well-established tradition of timber-framed construction which favoured the adoption of multiple-flue axial stacks. In south Norfolk, the plan incorporating an axial stack (within the main body of the house) remained the dominant type until changing architectural tastes in the second half of the seventeenth century dictated the adoption of plans with double gable end chimney stacks which were more aesthetically in tune with the times but less efficient in their use of brick. Early examples of this type of plan, like Dairy Farm, Tacolneston (c.1640) (see Figure 16) appear at the time of the Civil War, but are more commonly found after the Restoration, as at Crossways Farm, Chedgrave (c. 1669).60

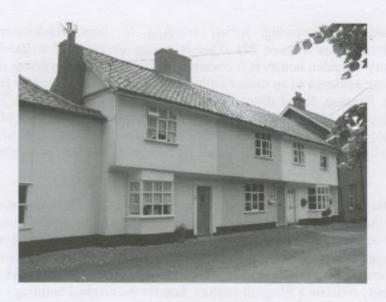
Figure 20
Photograph of Oak Cottage/Yellow Cottage, Market Place, New Buckenham.
(Photograph by Adam Longcroft)

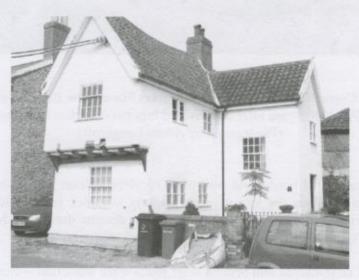
Figure 21
Photograph of No.1 Chapel Street, New Buckenham.
(Photograph by Adam Longcroft)

Oak Cottage/Yellow Cottage is not the only jettied building in new Buckenham. Another example, though much smaller in scale, is No.1 Chapel Street (see Figure 21). This site belonged to William Verdon in 1573 and it may be this house that was charged the landgable rent, high in New Buckenham terms, of 3 ½ d in 1542. As late as 1696 the site measured one acre which is extremely large by New Buckenham standards. Probably by 1615, and certainly by 1634, it had become a dwelling house. The 25-inch OS map of 1883-4 shows what may be part of an attached front range along Chapel Street, which has now gone.

Again, prior to the launch of the NHBG project in New Buckenham, this building was believed to be a small sixteenth-century townhouse or commercial 'lock-up'. However, detailed recording of the building has led to two alternative scenarios. One suggestion is that the jettied western range was a cross-wing with an open hall to the south. All evidence of the hall has gone, but the former 'barn' reported to have occupied the site within living memory may have been the remains of this building. Alternatively the building may have been an independent gatehouse structure open at the front and possibly at the rear and with an elaborate chamber above complete with oriel window. If the structure was a gatehouse – which on current evidence seems most likely – then the site must have been one of considerable status and importance. A fifteenth-century date has been tentatively ascribed to this gatehouse, though the existing stack and rear range appear to have been added in the sixteenth century.

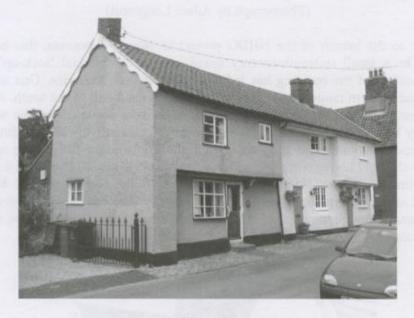
Figure 22

The third and last surviving jettied building in New Buckenham is Corner Cottage/Crawford's (See Figure 22). This is a rare example of a late-fifteenth/early-sixteenth-century Wealden house. It is documented from 1542 when it was owned by John Feke. Tantalising evidence of an earlier building on the site is indicated by large post-holes near the street frontage, found during a recent archaeological evaluation. The chimney was in grave decay in 1579; its repair, or possibly the replacement in brick of a timber-built chimney, could have signalled the sixteenth-century flooring-over of the hall. A craftsman's rather than a merchant's house, its owners in the late sixteenth century were coopers.

Around 1660 the building was sub-divided into two properties. The existence of the former open hall and the open hearth associated with it are betrayed by smoke blackening at first floor level. Though an early-sixteenth-century date for the building remains a possibility, the jetty framing is unusual and may be an early technique. It also occurs nearby at Yew Tree Farm, Forncett St. Mary. The floor framing of the east end employs central tenons which, again, may indicate a fifteenth-century date for the original building.

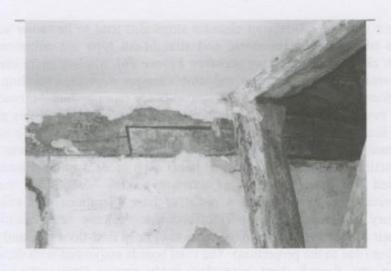
Figure 23

Ten examples of edge-halved and bridled scarf joints were identified – these vary in length considerably, with the large examples normally being earlier (fifteenth and sixteenth century) (see Figure 23).

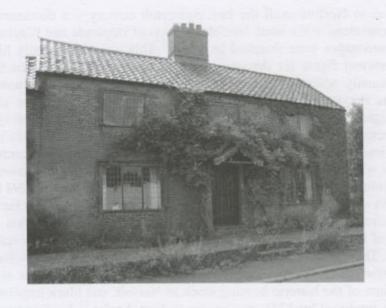
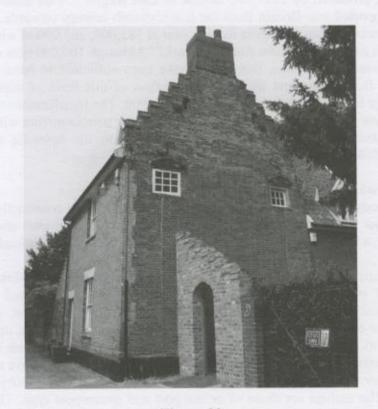
Figure 29

Red brick 'skin', Pinchpot Cottage (top), and white brick 'skin', Saffron House (bottom),

Thus, whilst Lavenham conforms to the popular perception of what a medieval East Anglian town should look like, the medieval and post-medieval timber-framed housing stock of New Buckenham remains hidden behind a facade of brick. That so many buildings acquired continuous brick frontages in the nineteenth century is interesting in itself. In some cases cheap red brick was employed, in others the same bricks were laid in a cost-saving rat-trap bond. Quite frequently, owners used the more expensive (and more fashionable) white bricks (see Figure 29).

Pinchpot is built on a site that was probably newly developed in the early-mid sixteenth century (refer back to Figure 29). Documentary sources suggest the house was rebuilt between 1623 — when it is called a vacant tenement — and 1625 when it was a 'messuage built'. This was confirmed by dendrochronology which gave a date of 1624. It was bought in 1622 by Osbert Stacy, landlord of the Bull Inn, who left it to his wife Elizabeth in 1633. 106 The landgable rental of 1634 lists 'The widow Stacy for pinchpot hawll' - an ironic reference to a house paid for by short measure (pinching the leather pot) at the inn. This house seems to be a classic example of an early-seventeenth-century symmetrical lobby-entrance house. It is also notable for a very special plaster ceiling which survives in fragmentary form on the first floor west chimney bay. This plaster ceiling has an elaborate frieze with griffin motifs. There are four griffins in each frieze (the west frieze has gone) and the ceiling panel is a grape vine ornament with a central boss. The plaster work is of very good quality though decayed at present. It is the only one of its type to be discovered in the town. The survival of the plasterwork in the chimney bay, part of a scheme which no doubt extended to the rooms on either side, effectively identifies this building as the one built by Osbert Stacey. It is noteworthy that although the windows to the front and sides were large and glazed, those to the rear seem to be unglazed mullioned windows of medieval pattern. The house was evidently designed for display, hence the fenestration, the plaster work and the (unusual) ogee external braces facing down the street.

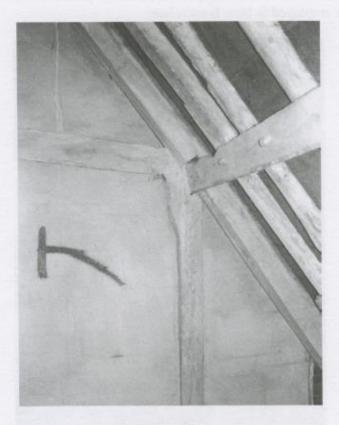
Figure 32

Queen-post roof at The Pleasance, Queen Street, New Buckenham. Early 16th century.

Whilst none of the New Buckenham buildings can compete with the elaboration seen at King's Head Cottage, the queen-post roof was a favoured type amongst the carpenters working in the town. The examples so far identified are at Thatched Cottage, Marsh Lane, Gingerbread Cottage, Church Street, The Pleasance, Queen Street (See Figure 32), No.1 Chapel Steet, and the White Horse/White Horse Cottage. The earliest of these queen-post roofs is that at No.1 Chapel Street – a building which has been shown to be a gatehouse associated with a high status site. The evidence for the existence of the queen post is fragmentary due to a comprehensive rebuild in the seventeenth century, but the gatehouse appears to be mid-late fifteenth century. The other four examples appear to date to the first half of the sixteenth century (c.1500-1550) with the likelihood that most were erected between 1500 and 1530. It would seem, therefore, that there was a clear progression in roof forms in New Buckenham, with the crown post the dominant type in the fifteenth century. It will be

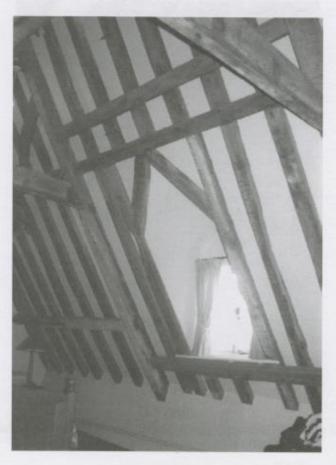
Figure 33

Butt-purlin roof, Saffron House, Market Place, New Buckenham. Early 17th century.

We know from documentary evidence that the second half of the sixteenth century witnessed an increased tendency to integrate properly floored 'attics' in houses. However, the provision of an attic required roofs which were suited to the job - new types were favoured which did away with inconvenient and intrusive posts within the roof space. One roof type which measured-up was the clasped-collar purlin roof in which the lone purlins in each pitch were 'clasped' between collar and principal rafter. In New Buckenham this particular type of roof appears to supersede the queen-post roof around 1550 and remains in use into the early seventeenth century. By this time, however, it too faces competition from a new type of roof - the butt-purlin roof. A particularly fine example of the latter has been identified at Saffron House, a particularly tall early-seventeenth-century house of which only the parlour bay survives intact (see Figure 33). The site of Saffron House was owned by the Kendall family in 1542 and enlarged by purchase in 1560. The Kendalls were prosperous yeomen in the sixteenth century, rising into gentility in the seventeenth. Henry Kendall was given leave to enlarge the site towards the west and the north in 1627 and this dates the rebuilding. Truncated and re-fronted, it had become the steward's house for the adjoining Rookery (R3-4) by 1866. 101 The roof has tenoned butt-purlins in two tiers, some of them shaved. Only the principal rafters either side of the dormer window are pegged to the wall-plate. This elaborate system for supporting the dormer is an interesting example of structural anxiety about new building ideas. Obviously the concept of the dormer was sufficiently alien at this time to justify this type of contingency. The butt-purlin roof -

employed perhaps for the first time in new Buckenham at Saffron House — was to become the 'standard' roof type of the seventeenth and early eighteenth centuries in Norfolk. By the mid-eighteenth century, however, king-post and through-purlin roofs, often of quite crude construction, were employed in New Buckenham.

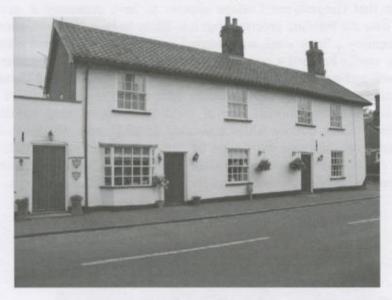
Figure 36
Dial House, King Street, New Buckenham. Late 15th century.
(Photograph by Adam Longcroft)

The second plan type to dominate prior to 1600 was a smaller, two-cell version of the one discussed above – comprising only a hall (open or otherwise) and a service bay (or shop unit). That this simple plan is found in buildings of medieval origin with open halls and also in those of mid-sixteenth-century date which were fully floored suggests that its inherent merits ensured its survival during a 'transitional' phase in the wider development of vernacular architecture within the county. One of the earliest examples of this plan is Dial House, King Street (see Figure 36).

This late-fifteenth-century building comprised both an open hall and an open service bay. The open hall was very large indeed and seems to be the prototype of other buildings in New Buckenham which conform to the same plan and which were apparently adapted mainly for storage or other commercial purposes. The building consists of five bays with tie-beams at head height on the first floor. The end walls have internally-trenched inverted arch braces above and below the girt and there are no pegs in the upper face of the tiebeams, which may suggest the roof was hipped at both ends. All the original timbers are sooted throughout the building. It is probably the house formerly Thomas Undyrwode's on which James Roberdes paid landgable in 1542. Undyrwode's will dated 1528 indicates that he was a housewright. 102 Roberdes's widow allowed the tenement to become 'waste next the street' in 1561 and the consequent repair might give a date for the insertion of floors and internal divisions. The very large landgable rent in 1634, 22 3/4 d., may include rent paid for a licensed encroachment beyond the original structure; the western chimney is built outside the frame. From the early seventeenth to the early nineteenth century the property included a tanyard. A possible parallel to this plan is to be found next door in The Beams. Here the same arrangement of hall, cross-passage and service is disguised within a subdivided property which now comprises both The Beams and the western end of Diken Cottage. This appears to be slightly later than Dial House. What appears to be an identical arrangement, but on a smaller scale and at a slightly later date again (c. 1500-1530?), can be seen at No.2 Chapel Hill, and No.3 Chapel Hill (both early 16th C.). Again, both hall and twin services appear to have been open to the roof, with ceilings inserted in the late sixteenth or early seventeenth century. Like Dial house, this property may have been built originally to serve a commercial function as a storage or workshop facility. Of similar date but larger in scale is Gingerbread Cottage (see Figure 37). Gingerbread Cottage is opposite the west end of the Church. It is clad in brick under a pantiled roof and there is weatherboard on the north gable wall. Inside there is a timber frame and between the frame and the brick there may be clay lump front and back. Gingerbread Cottage seems to have been built as an open hall house with a cross-passage and twin service rooms to the south. In Dial House and No.3 Chapel Hill, the services were open to the roof, but here at Gingerbread Cottage they were floored over, creating a chamber above. A second crucial difference was that Gingerbread Cottage appears to have possessed a smoke bay. It is impossible to date the building precisely but it is likely to be c.1500. At some time later in the sixteenth century a brick stack was inserted into the space occupied previously by the smoke hood or smoke bay and a new ceiling was inserted in the hall together with a rather impressive plank-and-muntin screen (see Figure 38). That Gingerbread Cottage appears to have incorporated a smoke bay rather than an open hearth in the middle of the hall floor suggests that it was a 'transitional' type of building which retained traditional medieval elements of the domestic interior whilst presaging developments which would, by the late sixteenth century, revolutionise the design of vernacular buildings. Indeed, within half a century of the erection of Gingerbread Cottage new houses in New Buckenham were being equipped not only with brick chimneys, but also with two continuous storeys.

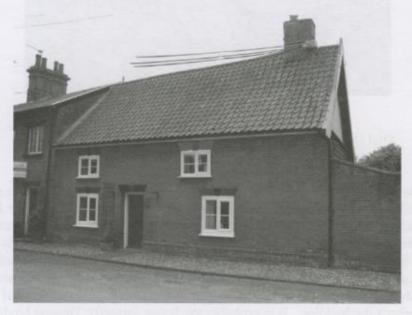
Figure 37
Gingerbread Cottage, Church Street, New Buckenham. c.1500.
(Photograph by Adam Longcroft)

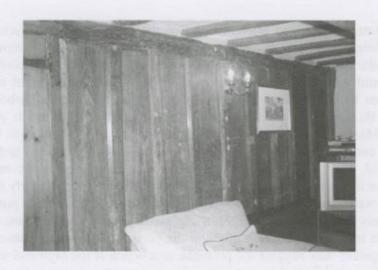
Figure 38

Plank-and-muntin screen, late 16th century, Gingerbread Cottage, Church Street, New Buckenham. (Photograph by Michael Brown)

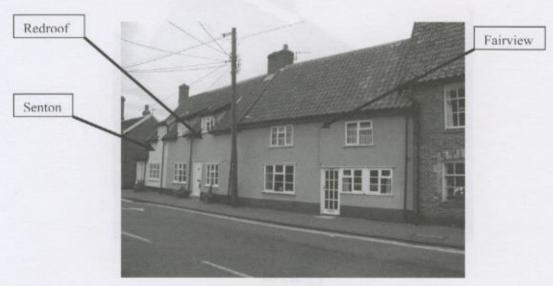
Figure 39

Fairview (closest to camera), Red Roof and Senton, King Street. Possibly an early sixteenth-century large, four-bay open hall (Fairview and Red Roof) with a storeyed service bay (Senton).

One of the characteristic features of this two-cell plan of hall and service in the houses of New Buckenham is the excessive length of the halls. In the case of The Beams/Diken Cottage, the original open hall was in excess of 30 feet in length. Even larger is that now contained within Senton/Redroof/Fairview in King Street. In this example, Senton appears to have originally constituted the storeyed (service?) end of a house which also comprised Red Roof and Fairview. The open trusses throughout Red Roof and Fairview suggest that they comprised a very large open hall of early sixteenth century date which contained no less than four bays. The purpose of these large halls is not entirely clear, but it is possible that they reflect commercial rather than domestic priorities (see Figure 39). 103

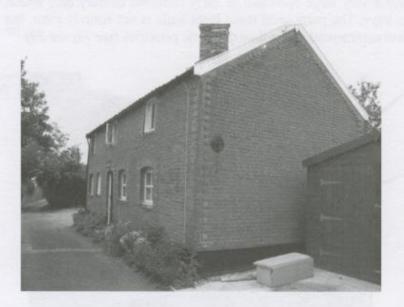
Figure 40

Thyme Cottage, Rosemary Lane, New Buckenham.

Perhaps the most unusual and arguably one of the most important discoveries in New Buckenham relates to the tiny cottage known as Thyme Cottage, on Rosemary Lane (see Figure 40). Like so many houses in New Buckenham this property is clad in nineteenthcentury brick and until recently was believed to have been built at that time. However, closer inspection by Paul Rutledge revealed the existence of internal timbers and detailed recording has shown that it is probably the hall of the second parish guild, either St Martin's or St Mary's. Humbly set in a back lane, it is not documented until 1670 when it is described as a cottage. It could always previously have gone with R35 and have been let out to the guild. With a flint-built extension it later (probably in the early nineteenth century) became three tiny cottages and in 1859 it is described as 'formerly three under one roof. 104 The wall studs are four-to-five inches wide, the central posts are, rather surprisingly, only six inches square (below the jowl). The wall-plates are also of modest section at seven by four inches. The studs in the north wall exhibit a pattern of peg holes which taken together may suggest the presence of a bench at the high end of the hall. The mortice in the first stud from the west may indicate a screen relating to the former screenspassage. In each central post there is a brace mortice for the former tie-beam. One of the timbers used as a joist in the inserted floor has a brace mortice and part of a dovetail mortice, suggesting that it was a former tie-beam. It also has the shallow section seen in the existing wall-plates and a chamfer to one arris. Given the asymmetrical placing of the empty brace mortices on the posts, and the matching asymmetry of the brace mortice in the soffit of the tie-beam, this chamfer would have faced the possible high end bench if this joist is the original tie-beam re-used. What we appear to have here is a very rare type of building indeed: a medieval (possibly fifteenth-century) guildhall comprising just a two bay hall with screens-passage at the low end and tall hall window in the upper bay. Although it is far from being in a good state of preservation, this building appears to be a (so far) unique survival in the county.

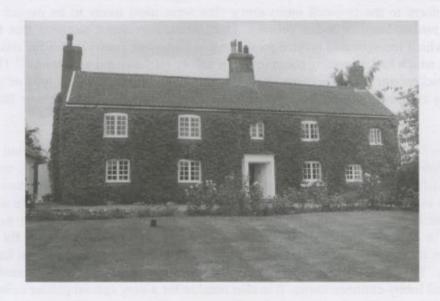
Figure 41
Turnpike Lodge, The Common, New Buckenham.
(Photograph by Michael Brown)

Turnpike Lodge conforms to the same basic plan arrangement (see Figure 41). This farmhouse lay at the southern edge of the common but within the town field called Bishop's Haugh Field. The field (perhaps part of a separate medieval deer park) originated as an outlier of the Bishop's estate at Eccles and it remained part of Eccles parish. The house site, described as 'a piece of land measuring 57 x 20 feet in the parish of Eccles in a field near New Buckenham called Busshopes Hawe Feld', was acknowledged by John Feeke in 1603 as having been purchased from Thomas Neve in 1601. In 1614 it is

described as a messuage with three closes containing six acres. Turnpike Lodge is clad in nineteenth-century brick today but like Pinchpot is entirely timber-framed. Again, like Pinchpot, Turnpike Lodge contains elements which are 'cutting-edge' (e.g. the lobby-entry plan) and also those which were archaic at the time of construction such as unglazed diamond mullioned windows. It is noteworthy that in both houses the principal staircase was originally located behind the main entrance (in front of the chimney stack) – this suggests that by the early 1600s the full potential of the lobby-entrance layout for creating a 'centralized' plan had been recognized by owners and carpenters, enabling independent access to first and ground floor rooms from the front entrance. Whilst the two lobby-entry houses recorded in New Buckenham are not particularly early, both contain elements of design which suggest that they were in tune with contemporary thinking. That only two examples have been securely identified in New Buckenham, however, indicates that the lobby-entry house was not widely adopted here. It may also indicate that the 1600s were a period of adaptation and improvement rather than one which saw the creation of large numbers of new houses – a reflection, perhaps, of economic factors pertaining at this time.
